INSPECT AZ. HOME INSPECTION

Property Address : 123 W Main St. # 124 Apache Junction AZ

Description of property

This double wide home on pads and piers is
apx 1200 sq ft.

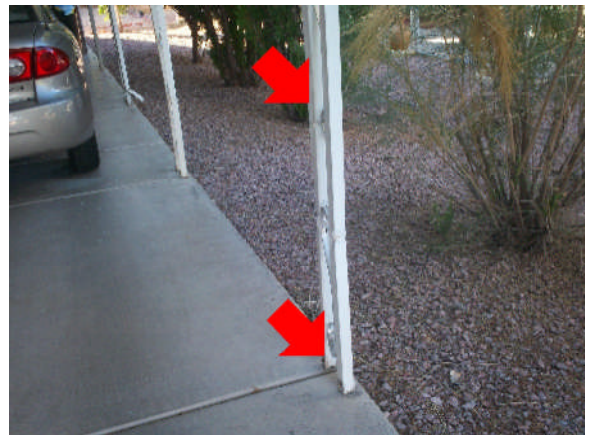
Exterior Collums

Condition *** An awning collum on the carport was bent/damaged and not properly attached to patio surface
Repair Recommended: The awning collum should be replaced and properly secured by a qualified contractor to assure proper attachment and support for the patio cover.

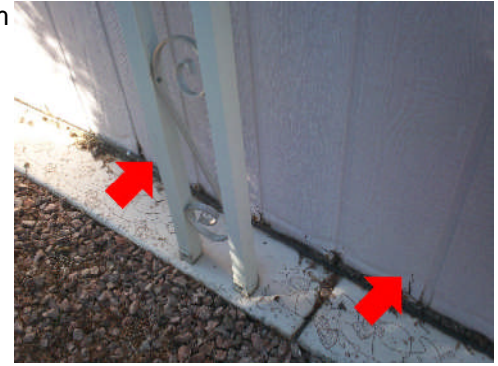
The storage shed walls, and the bottom 2X4 plate was water damaged

Correction Recommended: All of the damaged wood siding and framing will need to be replaced.

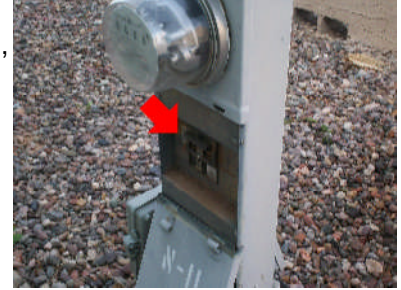
The Main Disconnect

A breaker to shut off the power to the home was located in the pedestal at the rear of home, and in the service panel on the exterior right/ carport side wall.

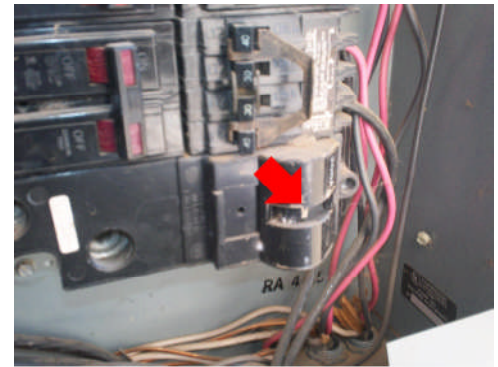
Circuit Breakers ***The main circuit breaker handle in the panel on the exterior wall was broken
Correction Recommended. The damaged circuit breaker should be replaced by an electrician.

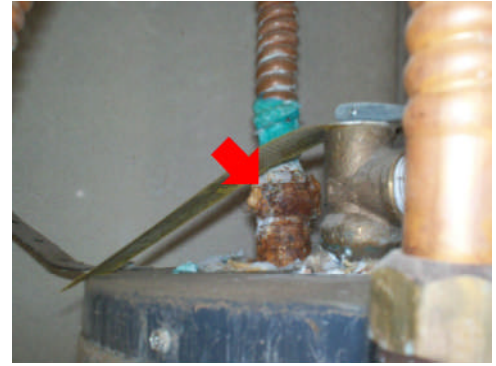
***Water connections on top of the water heater were corroded and leaking.

Correction Recommended: The connections should be replaced with proper fittings.

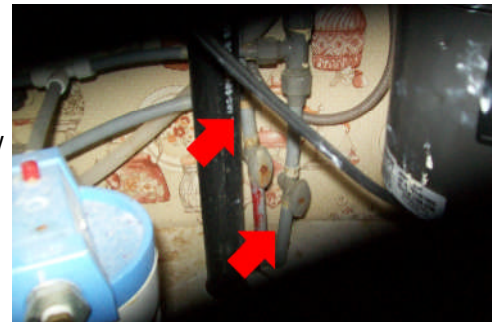
*** This building has polybutylene type water piping. This type of piping has had a history of failure due to a variety of reasons, and was a product of one of the countries largest class action law suits.

Recommended: For additional information on this type of plumbing , I strongly recommend researching , Polybutylene Piping on the internet, www.pbpipes.com and <http://ag.arizona.edu/AZWATERawr/nov94/leaks.html> , and consulting with a qualified AZ Licensed Plumber for more information.

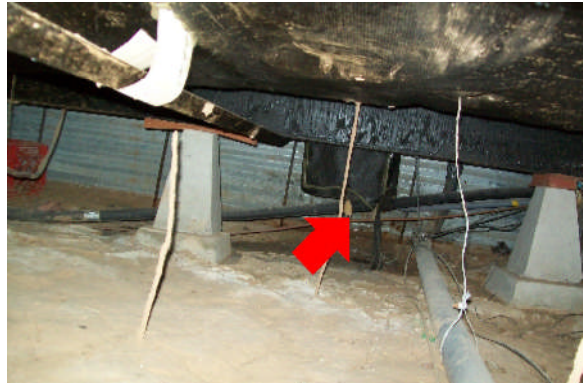
16. ***A sewer line was leaking in the crawl space.. Below the Master Bath

This is a potential health concern, and can cause this home to settle,

Correction Recommended:
The leaking sewer line should be properly repaired by a qualified plumber.

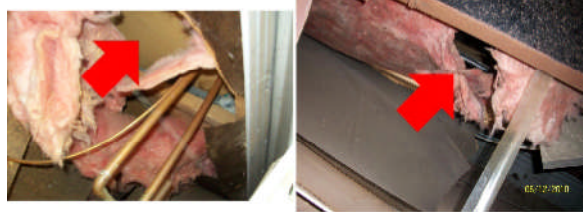
Floor Insulation/ Vapor Barrier

*** There were areas where the insulation in the crawl space has come loose, fallen down, leaving the area without insulation.

All displaced or improperly installed insulation should be secured back in place, and new insulation installed where necessary, to protect sub-flooring from moisture damage, prevent animal entry in the subfloor, and to help prevent heat and cooling loss.
