INSPECT AZ. HOME INSPECTION

Property Address : 123 W Main St. # 124 Apache Junction AZ

Description of property

This double wide home on pads and piers is
apx 1200 sq ft.

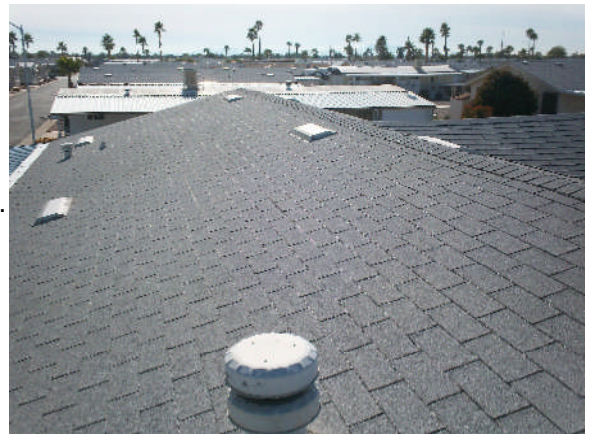
The inspection of the roof, in this section, was conducted from the roof surface.
I was able to safely walk on the surfaces of the roofing and visually examined the accessible roofing components.

The roofing surfaces were in good condition for the age of the surface.

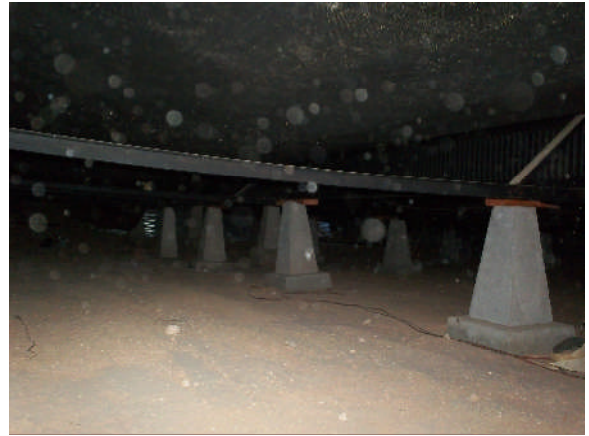
Concrete base pads with concrete piers.
